## **TURBIDITY MONITORING RESULTS LINCOLN PARK BEACH RE-NOURISHMENT PROJECT**

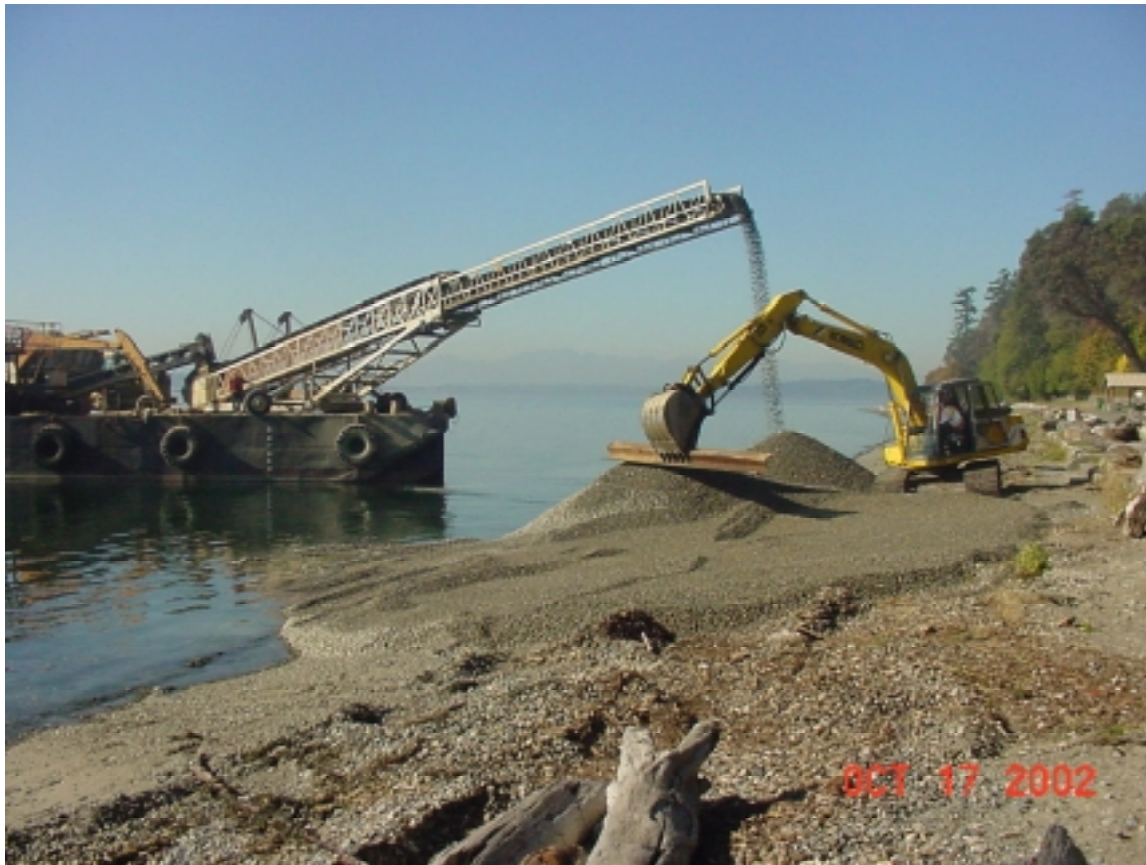
**Figure 1. Delivery of sand and gravel and initial spreading**

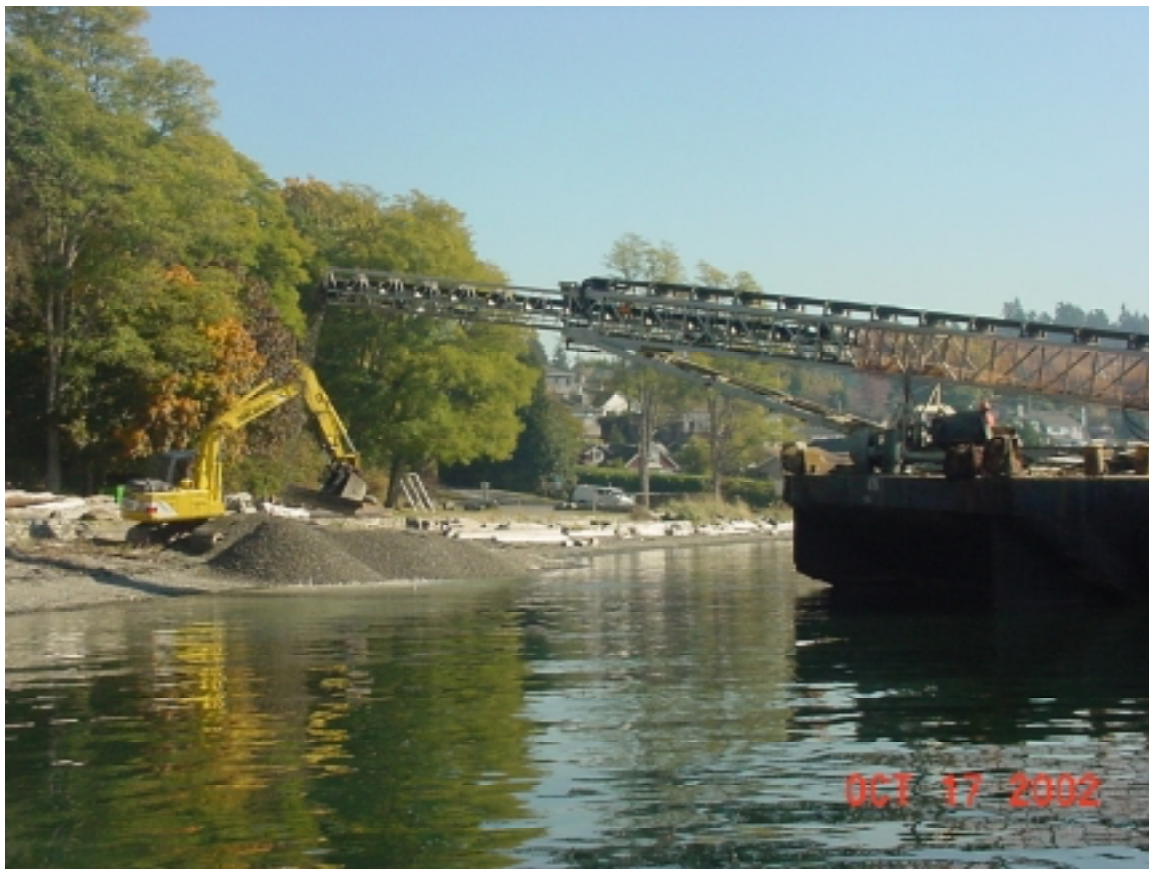
3. The water appeared to be very clear visually throughout the construction although, when the rising tide came into contact with newly placed material, a distinct turbidity plume was observed within the mixing zone (Figure 2). Of all the material, the most pronounced turbidity plume was associated with the fish mix that was required by a condition of the Hydraulic Project Approval. Visible turbidity appeared to settle prior to reaching the edge of the 150-foot mixing zone. Weather conditions during construction were extremely calm, which likely allowed the turbidity to settle more than if stormier weather had prevailed.

**Figure 2. Incoming tide hitting stockpiles (note turbidity plume adjacent to stockpiles)**
